NWA
ENVIRONMENTAL

Job location: 100 Cherry St. Port Townsend

Subject: inspection for demolition

Asbestos Bulk Sample Data

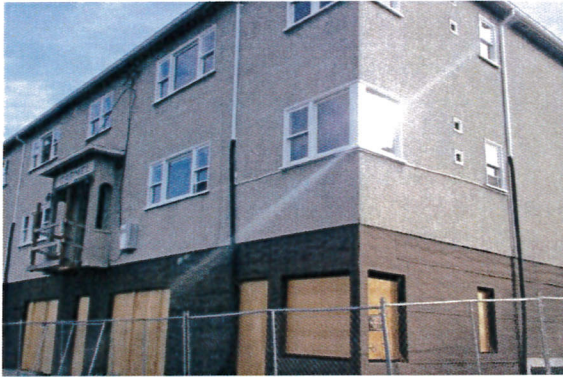
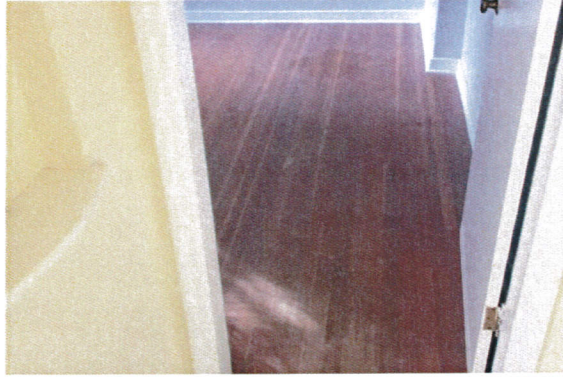
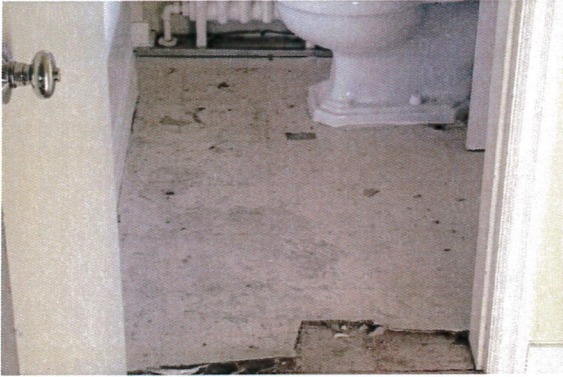
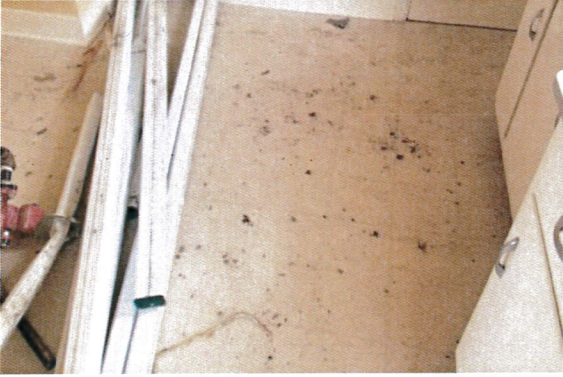
Structure is a 3 story building with the 1st story new structure constructed of wood and concrete lifting additional 2 stories. No samples taken in 1st level all existing exposed pipes are clean and no visible casting or ACBM present.

Second story exterior pebble and concrete siding in satisfactory condition and identified. Windows are wood with glazing material. Samples were taken throughout the floors to identify any possible Asbestos containing building materials. Multiple vinyl materials over top of wood flooring. Walls are lath and plaster. All materials are identified and in satisfactory condition.
